Our File - Notre référence
A1800106-D1-A1

15 November 2018

Re: **AVIATION SAFETY ADVISORY A1800106-D1-A1**
Quad City Challenger II Advanced Ultralight - Bracket Failure

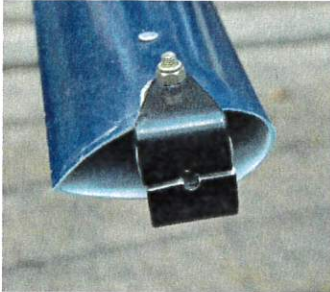
- The bracket had 402.2 hours since installation (including the accident flight).
- A fatigue crack was found across the bottom end of the bracket, through the bolt hole and parallel to the bracket sides (Figure 1).
- The initiation point of the crack was determined to be on the edge of the bolt hole.
- The fatigue region (Figure 2) accounts for more than 60% of the cross-section area of the bracket. It shows striations along the fracture surface, which are an indication of the fatigue cycles.
- The scanning electron microscope observation of the fracture surface found a significant number of secondary and parallel cracks underneath the surface of the bracket (Figure 3). These cracks resemble material delamination, a material defect introduced likely due to, or consistent with, the fabrication process used.

Figure 1. Fractured right front lift strut bracket

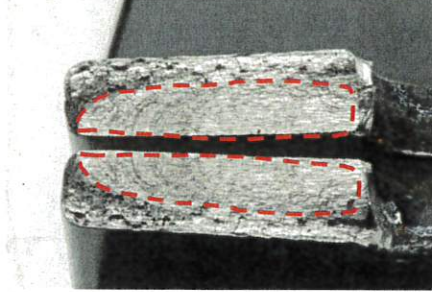
- The TSB was unable to determine exactly how long the fatigue crack had been present; however, analysis of the characteristics of the crack indicates that it existed for an extended period of time.

Figure 2. Fatigue region (inside the circle of red-dotted line) and fatigue striations

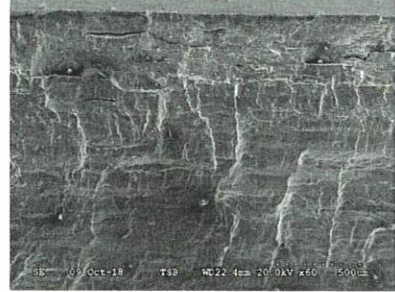
Figure 3. Secondary and parallel cracks underneath the surface of the bracket
