Air Transportation Safety Investigation Report A1800153

COLLISION WITH TERRAIN

Piper PA-28R-200, C-GDUM
Brantford Airport, Ontario
13 November 2018

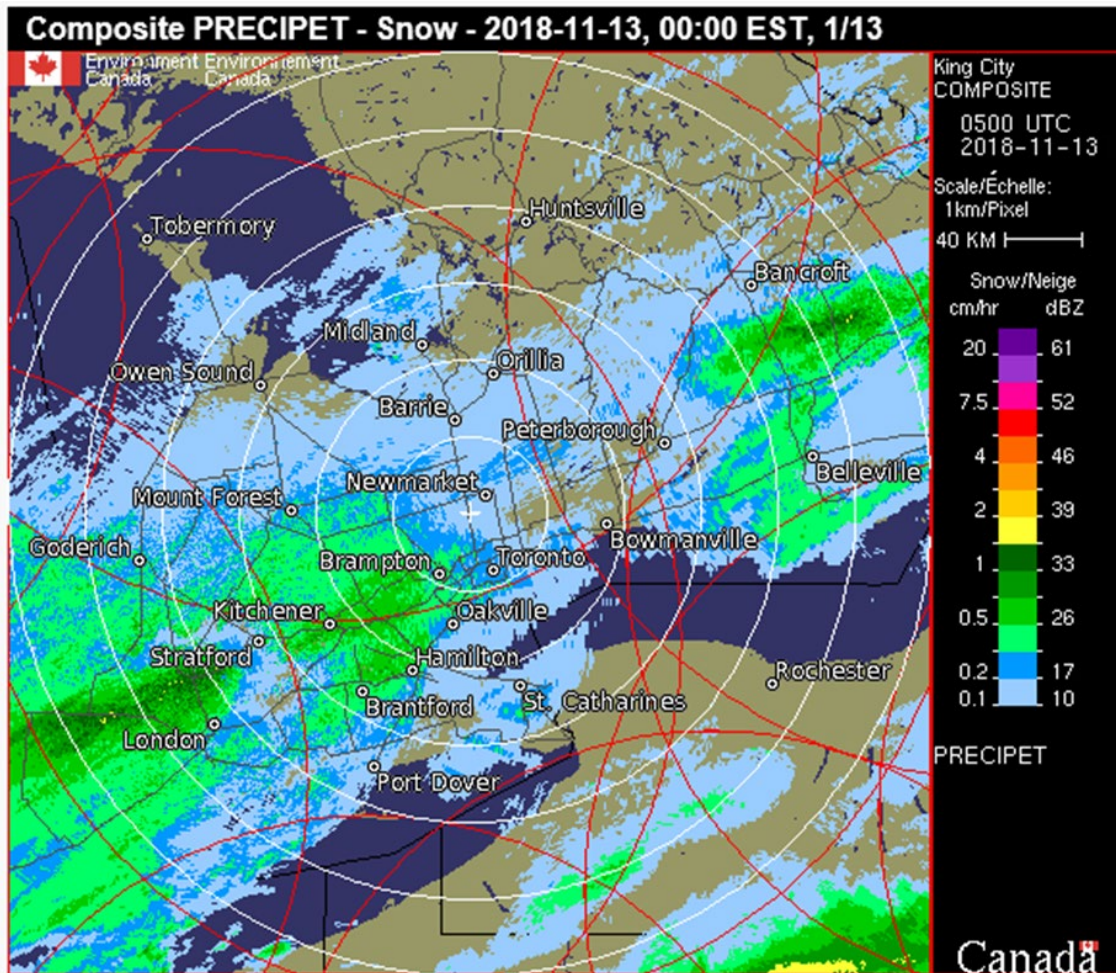
Based on historical weather radar data (Figure 1), there was precipitation in the form of rain or light snow at CZBA at the time of departure. The aerodrome routine meteorological reports from the 3 closest stations indicated visibilities as low as 1 statute mile in snow showers, and cloud ceilings at 1900 feet, with light winds and outside temperatures of around 0 °C at the surface.

Precipitation in the form of rain and/or snow was also recorded west of CZBA, and reduced visibility was reported for the entire route from CZBA to CYFD. With the freezing level at the surface, in-flight icing conditions were prevalent within this area of precipitation and within the clouds in this area.

Figure 1. Weather radar image showing system covering southeastern Ontario around the time of departure from CZBA (Source: Environment and Climate Change Canada)
