Air Transportation Safety Investigation Report A19C0053

COLLISION WITH TERRAIN

Piper PA-12S Super Cruiser, C-FYDN (private)
Domain Lake, Ontario
28 May 2019

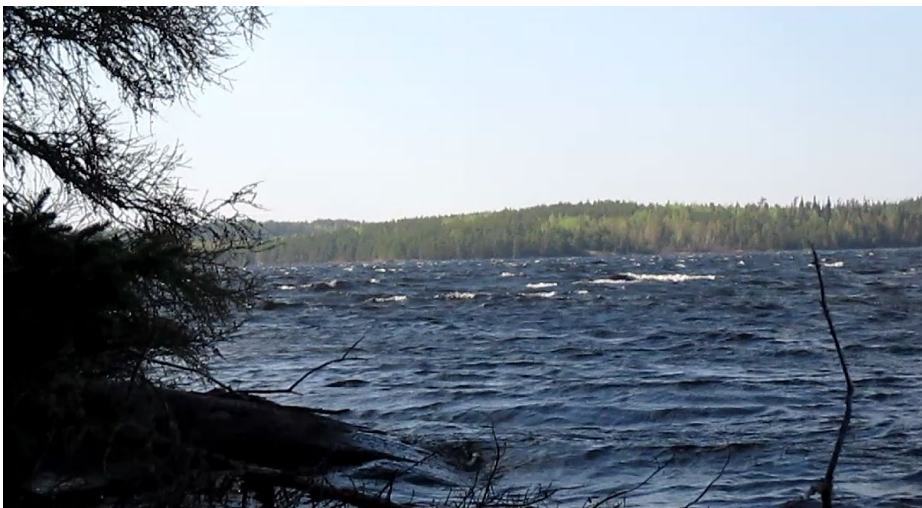
Figure 2. Choppy water on Optic Lake at 1711 (Source: Third party, with permission)

As the canoeists continued their journey around the shore of Optic Lake, they experienced difficult paddling conditions due to strong southwesterly winds and high waves (Figure 2).

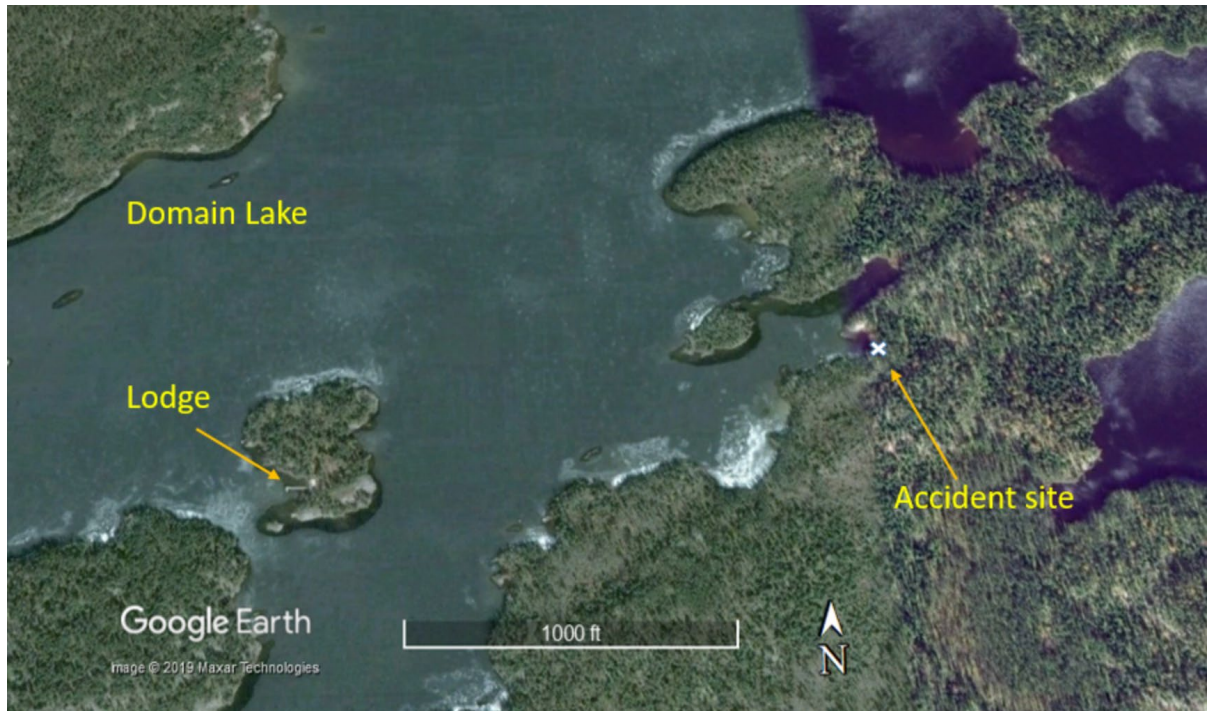
Figure 3. Accident site (Source: Google Earth, with TSB annotations)

The aircraft collided with trees and terrain on the shore of Domain Lake (Figure 3) on a southeasterly heading, with a nose-down attitude of approximately 30°. The aircraft struck trees and then a granite rock at an elevation of 1394 feet ASL.

Before impacting the granite rock, the propeller cut through a tree, indicating that the propeller was rotating and that the engine was producing substantial power at the time of impact. There was no wreckage trail.
