Air Transportation Safety Investigation Report A20Q0023

COLLISION WITH POWER LINES

Privately registered
Cessna 150M, C-GYEV
Les Cèdres, Quebec
17 February 2020

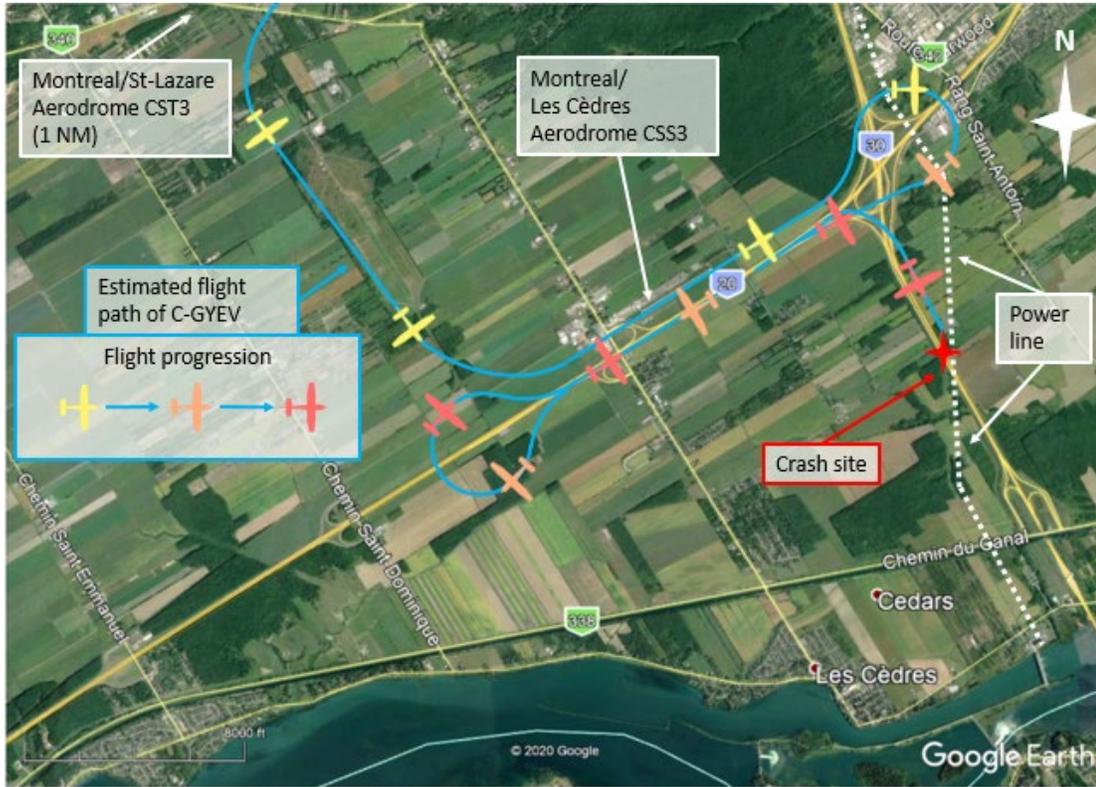
Figure 1. Estimated path of the occurrence aircraft (Source: Google Earth, with TSB annotations)

At approximately 1827¹ on 17 February 2020, a privately registered Cessna 150M (registration C-GYEV, serial number 15078827), with a passenger seated on the right and the pilot seated on the left, took off from the Montréal/St-Lazare Aerodrome (CST3), Quebec, for a night flight under visual flight rules (VFR). At approximately 1830, the aircraft conducted an approach to Runway 07 at the Montréal/Les Cèdres Aerodrome (CSS3), Quebec, followed by a pull-up. The aircraft then conducted a 180-degree turn over the interchange between Highway 20 and Highway 30 and flew westbound over Highway 20 at a very low altitude² (Figure 1).

At approximately 1834, the aircraft conducted another 180-degree turn, flying eastbound over Highway 20 at a very low altitude. When it was close to the interchange between Highway 20 and Highway 30, the aircraft turned south and flew over Highway 30, still at a very low altitude. At approximately 1836, the aircraft struck power lines crossing Highway 30 at kilometer 7 and crashed to the ground. The 2 occupants received fatal injuries. The aircraft was destroyed. Numerous calls were made to 911 by individuals who witnessed the accident. Emergency services arrived quickly at the scene of the accident.

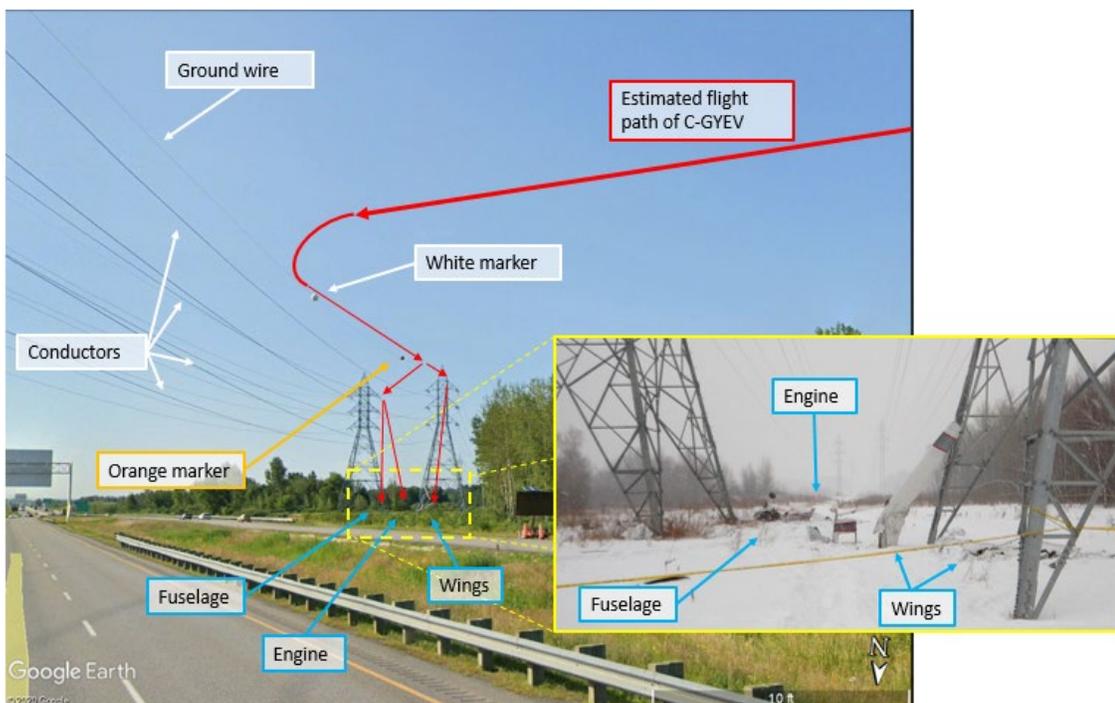
Figure 3. Estimated path of the occurrence aircraft and inset picture of the crash site (Source of main image: Google Earth, with TSB annotations. Source of inset image: TSB)

The accident occurred at kilometer 7 on Highway 30, where 2 parallel power lines, installed approximately 21.5 m (70 feet) from each other, cross the highway. These 2 power lines, which were struck by the aircraft, are operated by Hydro-Québec. The 1st point of impact was the power line ground wire⁵ on the west side. This wire extends over the highway at a height no greater than 30 m (98 feet).

Impact marks on the tip of the aircraft's left wing revealed that the initial impact occurred with a (white) marker installed on the ground wire. The dent in the wing observed between the wing strut and the cabin door led to the conclusion that following this 1st impact, the aircraft continued on its path, with the left wing sliding laterally along the ground wire and striking a 2nd (orange) marker, 75 m (246 feet) further.

As the aircraft continued to slide along the ground wire, the wire spliced the roof, which separated from the rest of the aircraft, and the aircraft broke into 2 parts:

- a part with the 2 wings, which continued along the ground wire until it struck the hydro tower 75 m (246 feet) beyond the orange marker and crashed to the ground;
- the rest of the aircraft (roofless fuselage), which was thrown more than 14 m (46 feet) further on the power line conductor⁶ on the east side, before striking the tower on this line.

When the roofless fuselage struck the hydro tower, it separated into 2 other parts:

- the rear part of the fuselage and cabin, which struck the ground near the base of the hydro tower;
- the engine (nose of the aircraft), which struck the ground a bit further, bounced, then came to a rest on the ground.

Figure 3 shows the aircraft's estimated path, as well as the markers and wires that were struck. It also provides an image of the crash site and wreckage.
