Air Transportation Safety Investigation Report A20Q0023

COLLISION WITH POWER LINES

Privately registered
Cessna 150M, C-GYEV
Les Cèdres, Quebec
17 February 2020

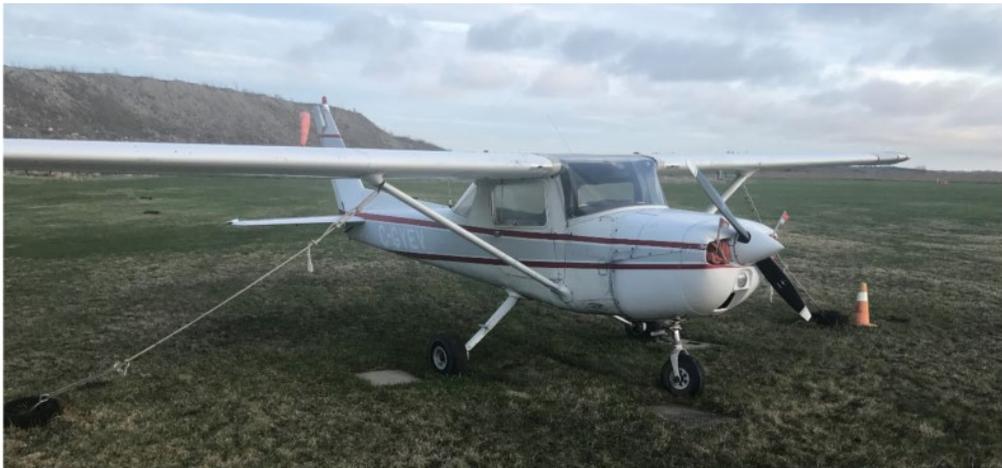
Figure 2. Occurrence aircraft (Source: previous owner)

The aircraft had no known deficiencies before the flight. The aircraft did not have a recorder on board, and regulations in effect did not require that it have one.
